# Manufacturing of Power Turbine Casings

**GREGOR TIMMERMANS**  
SULZER TURBO-  
MACHINERY SERVICES

In the past few years, Sulzer Elbar, a company of Sulzer Turbomachinery Services, has developed the technologies for repair, modification and manufacture of power turbine casings and vane carriers. The manufacturing procedure of welding instead of casting offers distinct advantages in turn-over time, cost and material quality.

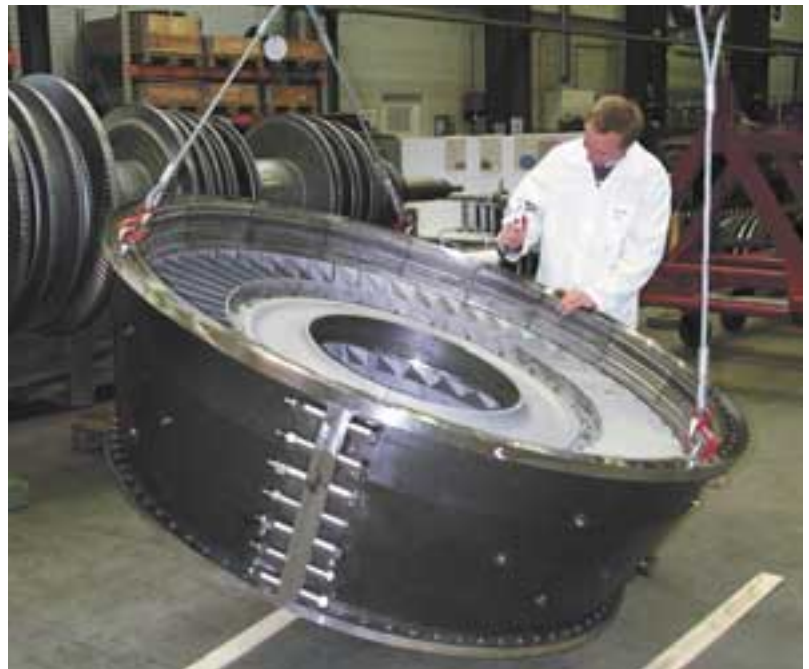
**2** Final quality check of a repaired turbine casing.
